Part III

Management Discussion of Major Projects

Estabrook Park

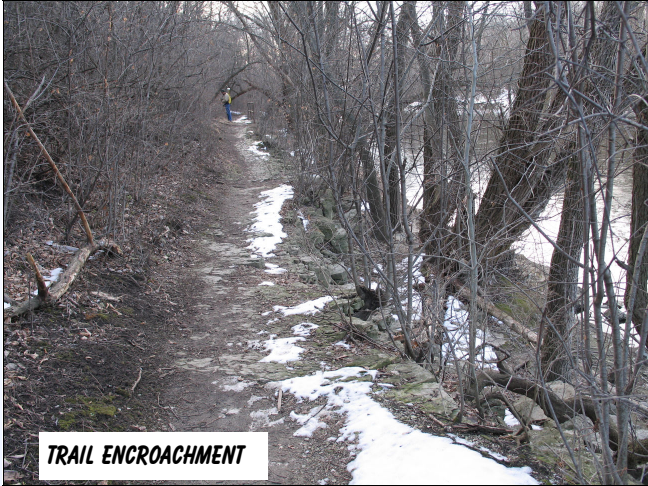
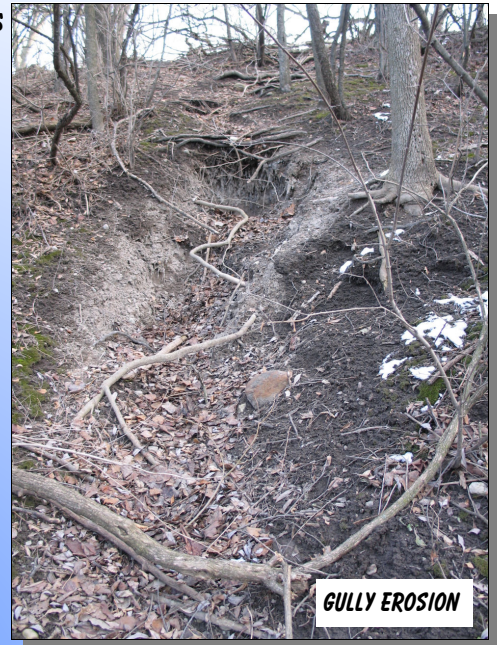
dense leaf canopy created by the invasive trees and shrubs in this area has created several problems. First, due to the dense shade, light conditions at the soil surface are minimal, resulting in little to no herbaceous plant growth. Factor in the 50% slopes on the site and the potential for significant sheet and gully erosion becomes evident. Second, severe encroachment on the trail by these unwanted trees and shrubs have left many portions of the trail isolated and inaccessible in the event of an emergency, creating unsafe conditions for trail users. This project is meant to address both of these conditions.

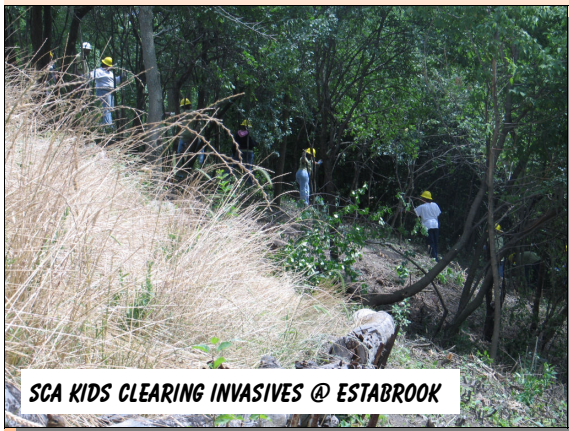
SCA KIDS CLEARING INVASIVES @ ESTABROOK

school kids did the vast majority of the tree and shrub removals. All of this work was performed by hand, a painfully slow and tedious process. As the woody plant material was removed from the slopes the Crew followed up with herbicide treatments of the stumps. The herbicide prevents resprouts and aids in establishment of the native plants on the site.

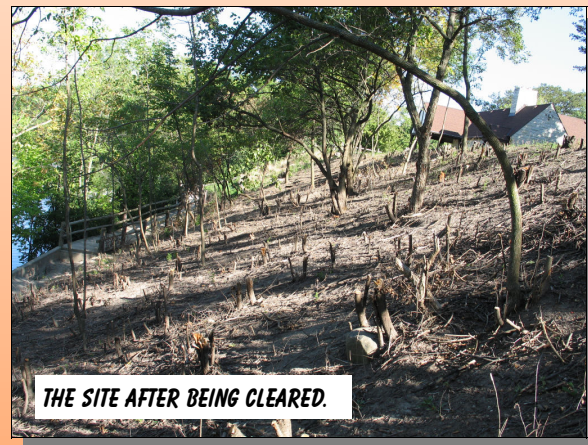
THE SITE AFTER BEING CLEARED.

Upon the completion of the vegetation removal the Crew used various erosion control techniques to limit offsite movement of soil. Over 12,000 ft.² of coir (coconut fiber) erosion control matting was installed. As this is a pilot project of sorts, two different methods were used for vegetating the site. The first method involved installing the 2.5" native plant plugs through the erosion control matting. In the fall, a group of 8 Americorps volunteers assisted in planting nearly 5,500 herbaceous plugs from over 30 species (species list on next page). Again, without this significant labor input the scope of this project would have been greatly reduced.

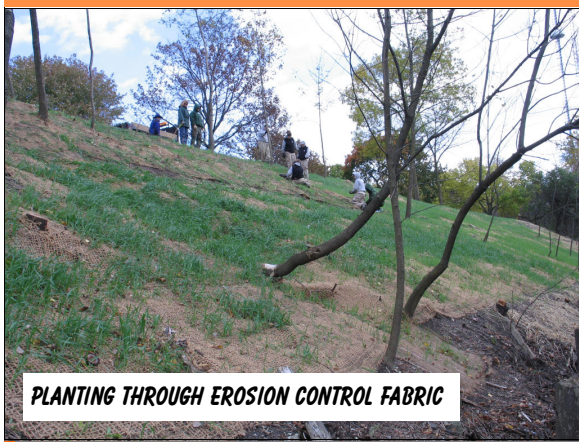
PLANTING THROUGH EROSION CONTROL FABRIC

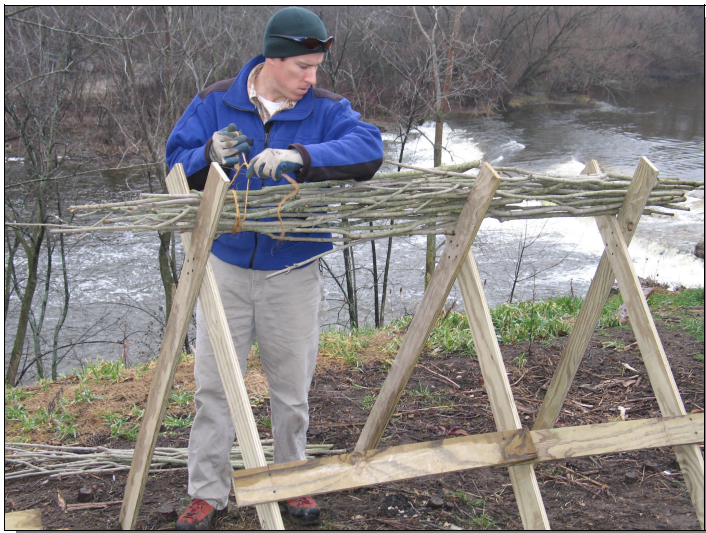
LIVE FASCINE ASSEMBLY

In addition to the seeding and planting the Crew installed a live fascine row (approximately 100 ft.) in the middle of the slope. Live fascines are bundles of live shrub cuttings, in this case gray and red-osier dogwoods, that are buried perpendicular to the flow of water on the slope (see photos below). A live fascine is an effective slope stabilization technique. It immediately reduces surface erosion and it protects the slope against shallow slides.

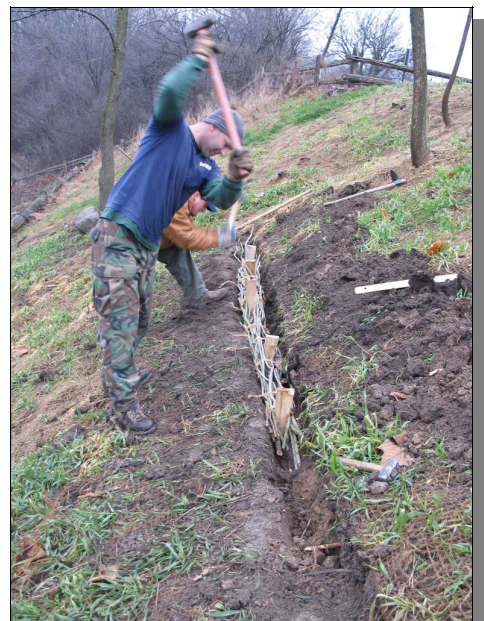
LIVE FASCINE INSTALLATION
